**Subject: Annual Inspection Report
Albertville Regional (Thomas J. Brumlik Field) Airport**

ANNUAL INSPECTION REPORT

July 27, 2010

ALBERTVILLE REGIONAL AIRPORT
(THOMAS J. BRUMLIK FIELD)
ALBERTVILLE, ALABAMA

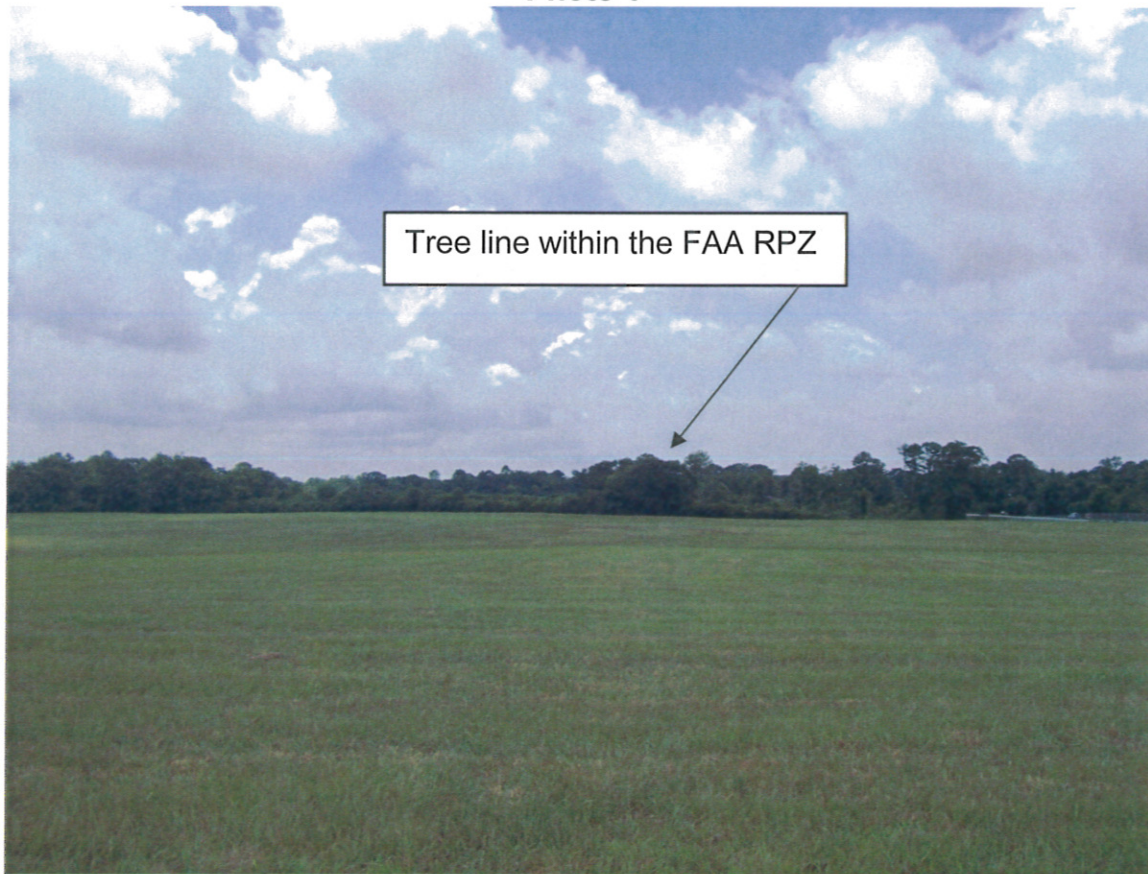
Photo 1

- Runway 5 – The FAR Part 77 34:1 approach slope is violated by trees 1119 feet from the runway end. The approach is limited to 24:1.

Runway 5 approach

- Remove all obstructions within the FAA Runway Protection Zone to accomplish an unobstructed 34:1 slope. The parcel of land on which the tree line is located is part of an ongoing land acquisition project began in

2008. This acquisition project needs to be completed to meet State and Federal requirements regarding ownership of the FAA Runway Protection Zone and the State required Approach/Departure Path. If the timetable for this acquisition is not in the immediate future the runway threshold may be displaced to provide the required 1200 foot cleared area.

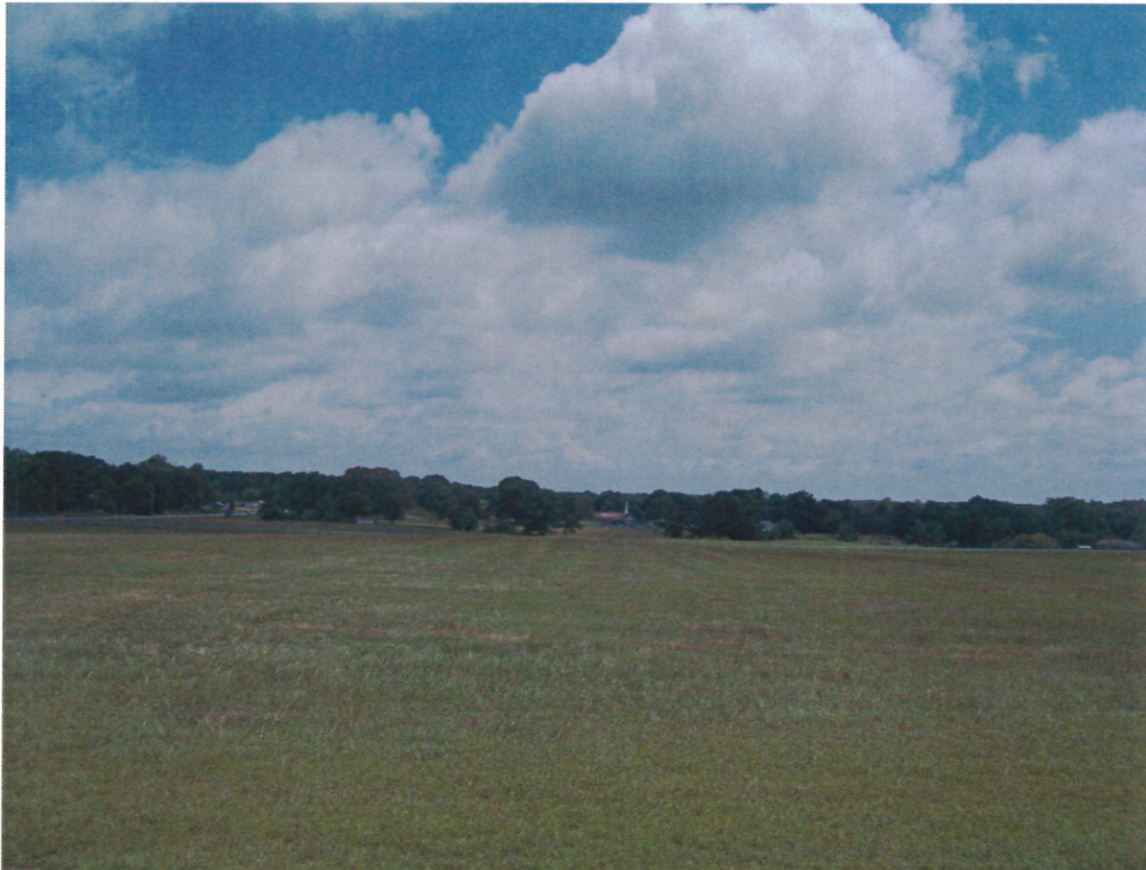
Photo 2

- The Approach/Departure Paths of both runways are unobstructed and meet licensing requirements.

Approach to Runway 23

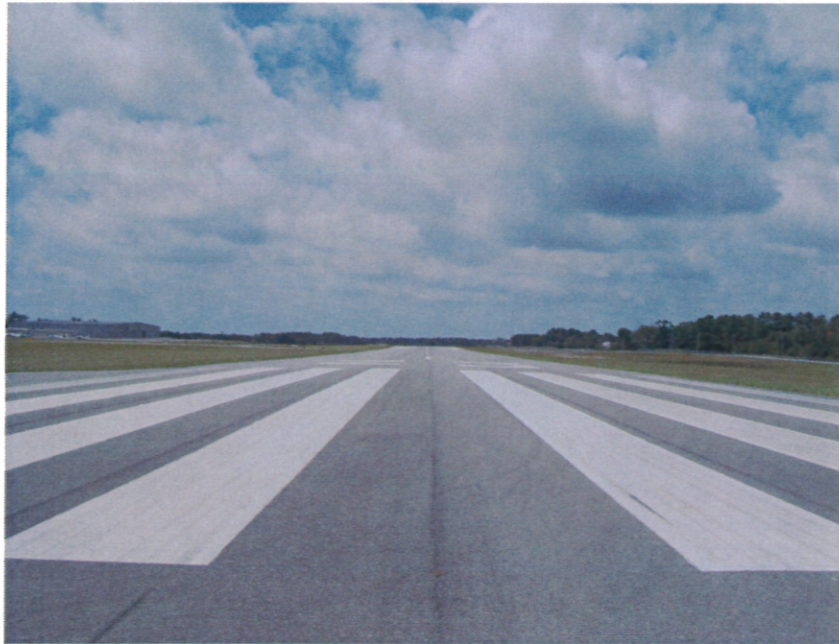
Photo 3

- ➔ The markings for all runways are in GOOD condition.

Runway Identifier markings of Runway 23

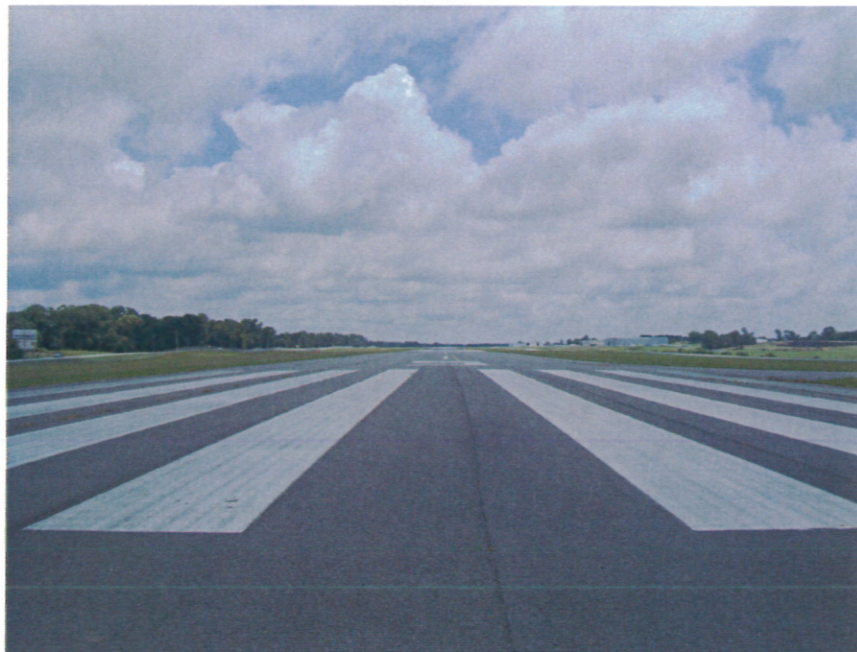
Photo 4

Runway Identifier markings of Runway 5

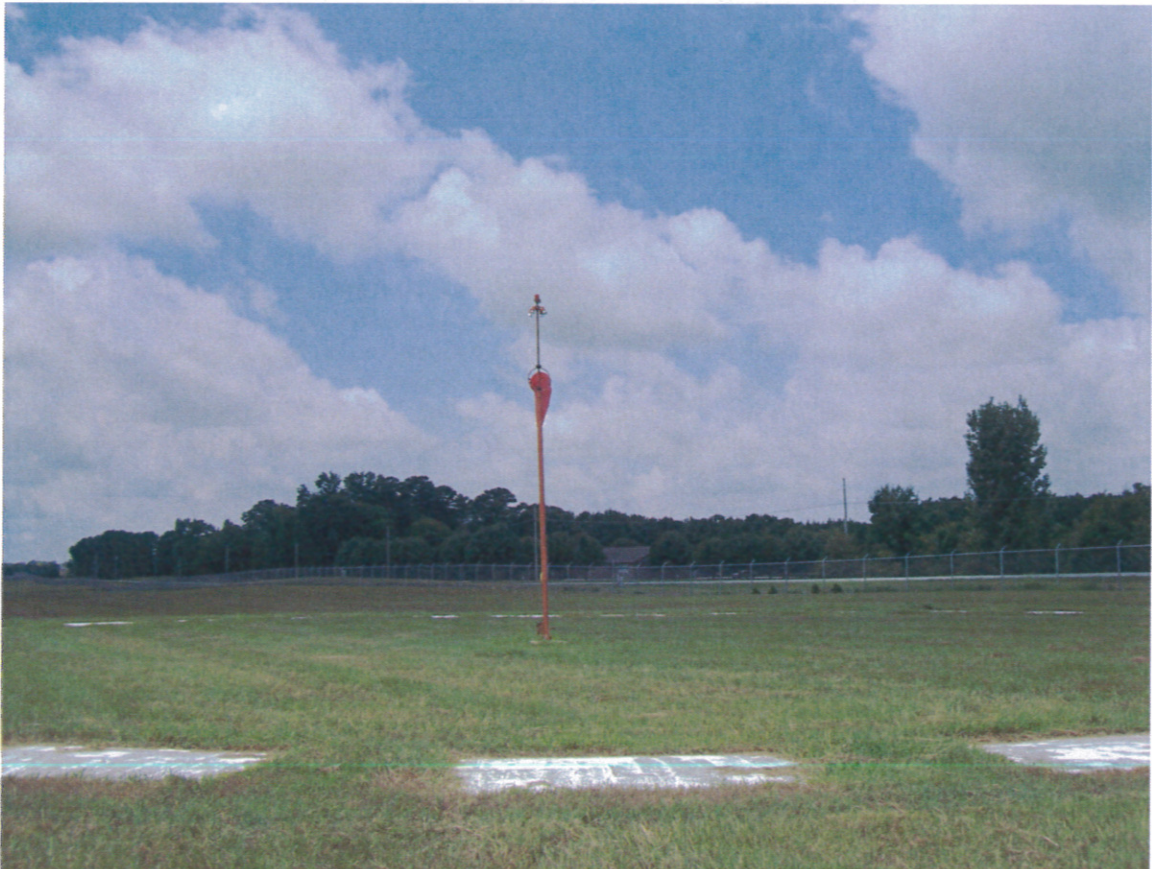
Photo 5

- ➔ The wind direction indicator (windsock) was inspected and found to be operational.

Windsock assembly and segmented circle

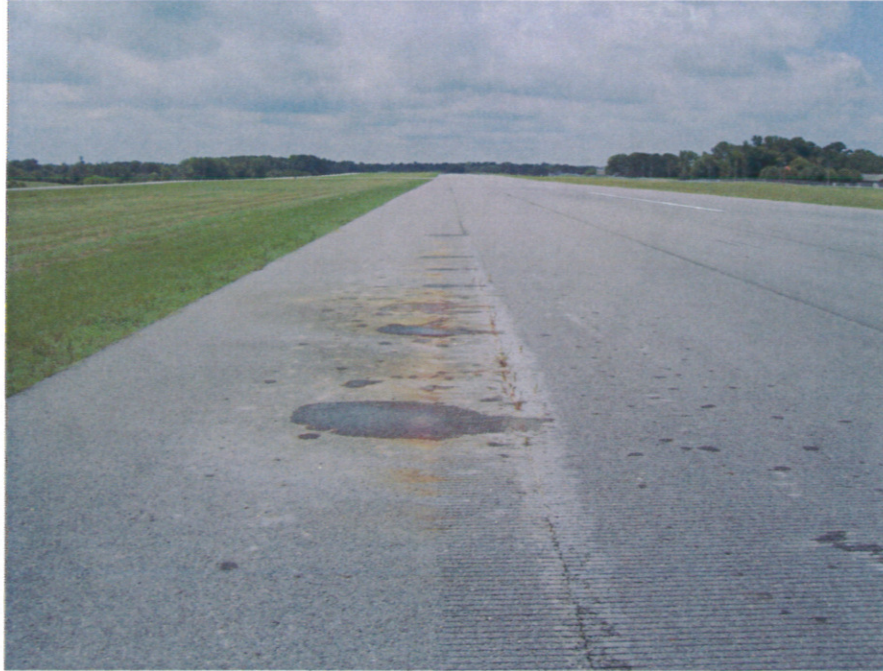
Photo 6

- ➔ The airport surface overall was found to be in excellent condition, however there is water seeping through the pavement along the outside paving lanes particularly along the southern outside paving lane near Runway 5.

Water seepage through runway pavement

- ➔ The condition of the areas shown above suggests a saturated base beneath the surface. If the saturation continues it could lead to premature failure of the base and the asphalt.
- ➔ The engineer for the airport should be consulted to determine if underdrains should be considered for the runway.

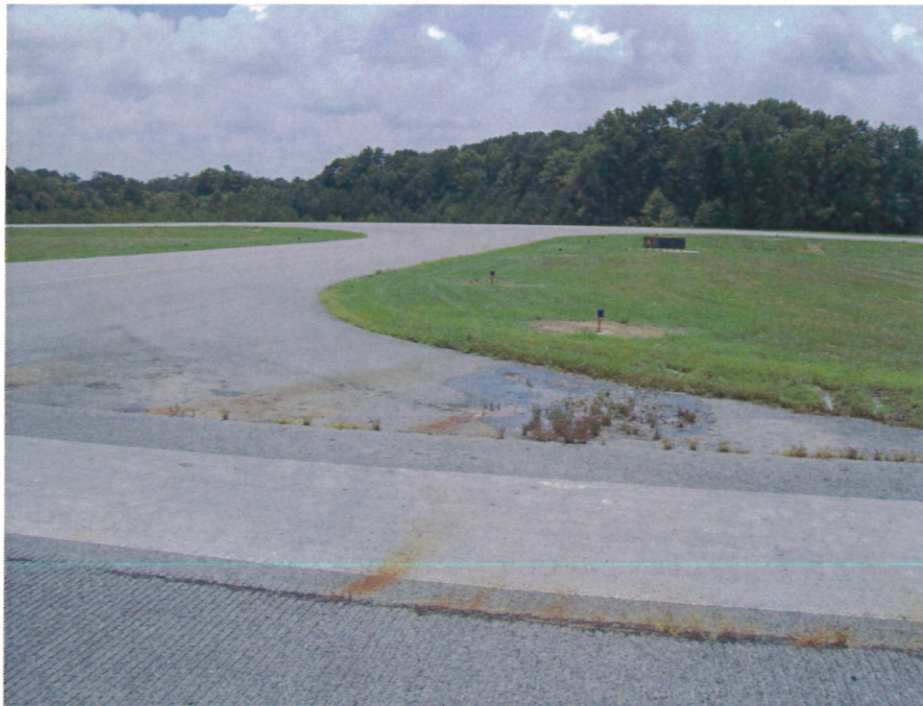
Photo 7

Water seepage along runway edge at taxiway connector

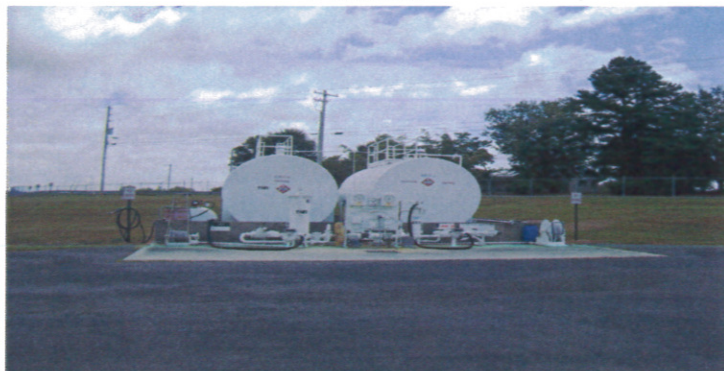
Photo 8

- ➔ The fueling area meets the requirements established by the Alabama Department of Transportation. However, the State of Alabama Department of Agriculture and Industries may have additional requirements for fueling systems that were not considered during this inspection.

Fueling area
